TIVAR® 88 High Performance Lining Solutions Engineering Case Book

**Applications, Case Studies, & Technical Resources
to assist your design process**

TIVAR® 88 HIGH PERFORMANCE LINING SOLUTIONS

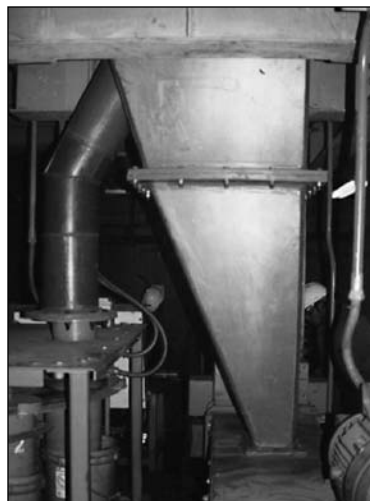
After
Sample collector manufactured completely with TIVAR® 88-2 eliminates build-up and quality control problems.

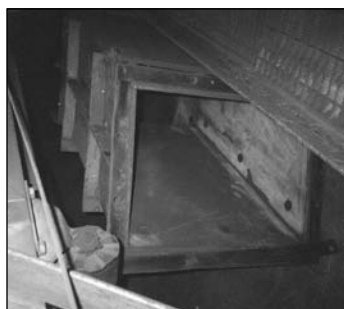
Original rectangular shape transfer chute.

The TIVAR® 88 chute lining and chute modification improved loading system operation by 35% and is considered a success by the copper mine.

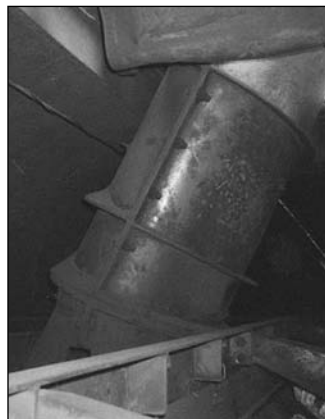
New round steel loading chute is lined with TIVAR® 88.
